TEARS OF HARDSHIP Mining Operation by CONGO DONGFANG INTERNATIONAL MINING SPRL (CDM)

and its impacts on the environment and the health of the Kasapa, Kamatete and Kamisepe local communities

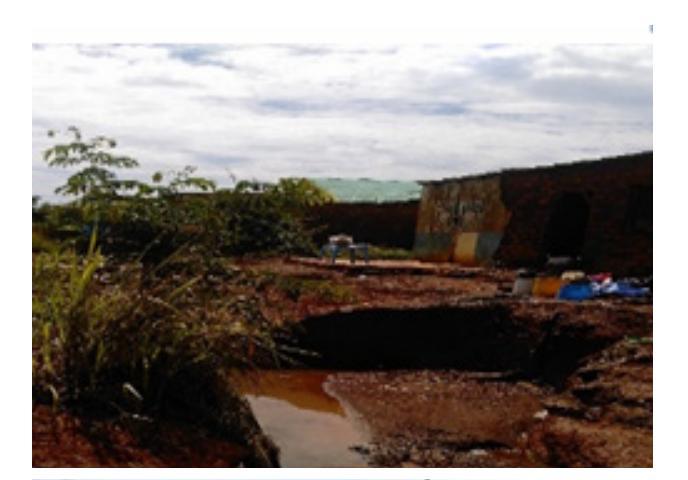
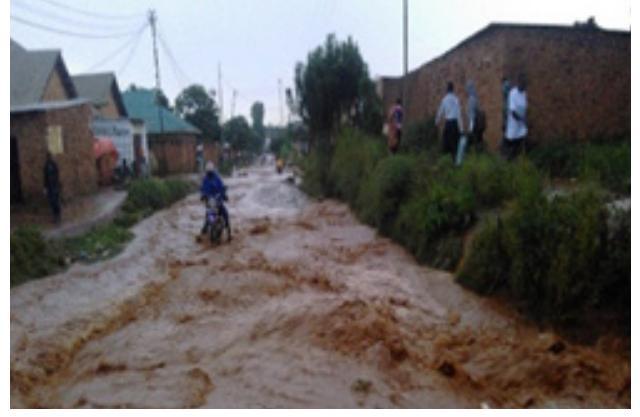
Photos by AFREWATCH on October 27, 2020

During the interviews with the researchers in December 2020 and January 2021, residents of Kamatete area confirmed that they had experienced repeated flooding of their plots of land by water from CDM plants. More than 20 testimonies collected from community members and leaders, including school and church leaders, reported the invasion of houses and several vegetable gardens by water from CDM's facilities downstream from their area. And yet, according to the latter, CDM promised them the construction of appropriate drains for the effective management of the impacts in order to channel this water.²⁹

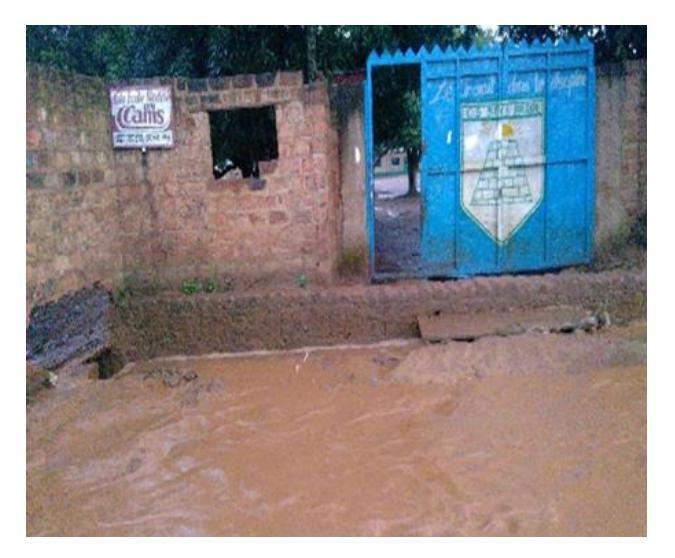
Photo by AFREWATCH on October 27, 2020.

Below is a photo of flooding in the area of the above-mentioned school:

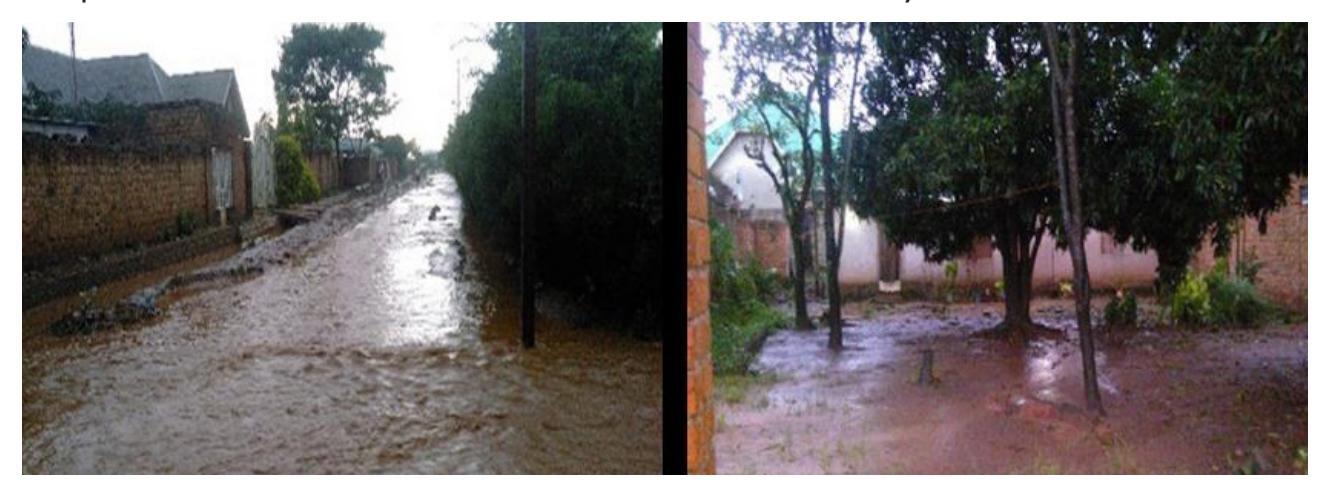
Photos by AFREWATCH on October 27, 2020

In addition to the erosion of roads, houses and schools caused by flooding from the water coming from the CDM facilities, the inhabitants of Kasapa, Kamisepe and Kamatete also complain about the corrosion of the metal roofs of their houses by the acids in the dust from the

plant of the same company. In their claims, the populations believe that this deterioration of roofs began on the houses along CDM Avenue. Contrary to the situation before, it took less than a year for the metal roofs on their houses to be covered with rust. The rust that has been attacking the roofing sheets on their houses since CDM settled in could be caused by the fume and toxic particles from the company every evening or even at night.

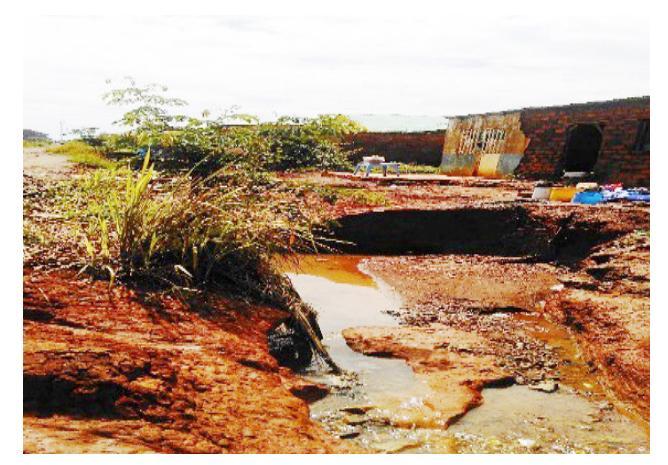
Photo by the AFREWATCH researchers on October 28, 2020

The photo below illustrates the risk of contamination of the well water consumed by the inhabitants in Kasapa, Kamatete and Kamisepe areas because of the liquid toxic waste dumped by CDM during the rainy season:

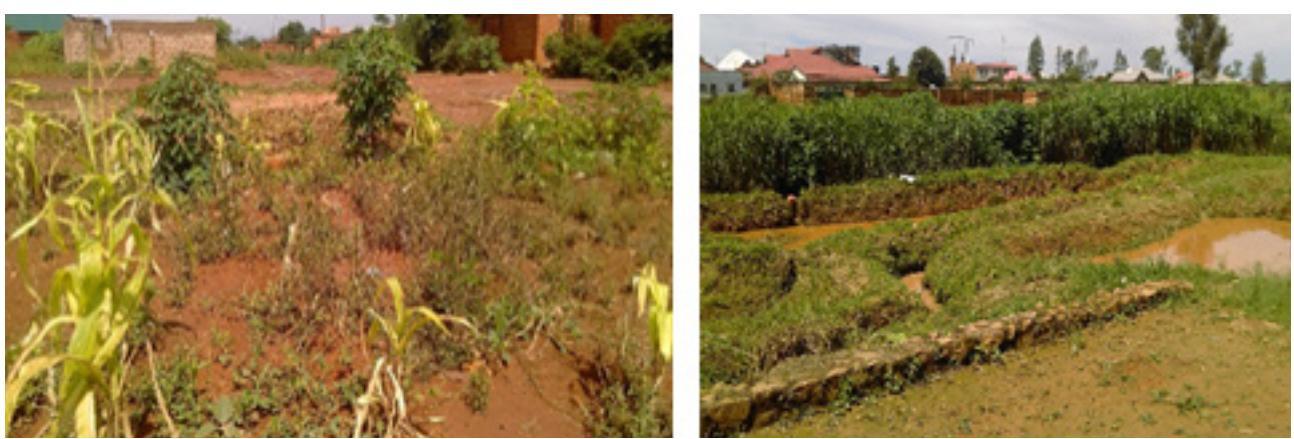
Photos by AFREWATCH on October 29, 2020

The owner of the ponds located near the bridge between Kalubwe area and Kamatete area said that this same waste water had caused the death of fish and other aquatic species. Another inhabitant of the same area reported the incident of a pig, which drank from that water and was found dead they day after.
